**NASA TM X-52990**

# SHOCK AND VIBRATION TESTS OF A SNAP-8 MERCURY PUMP

by Cecil L. O'Dear and Robert D. Follett Lewis Research Center Cleveland, Ohio

### ABSTRACT

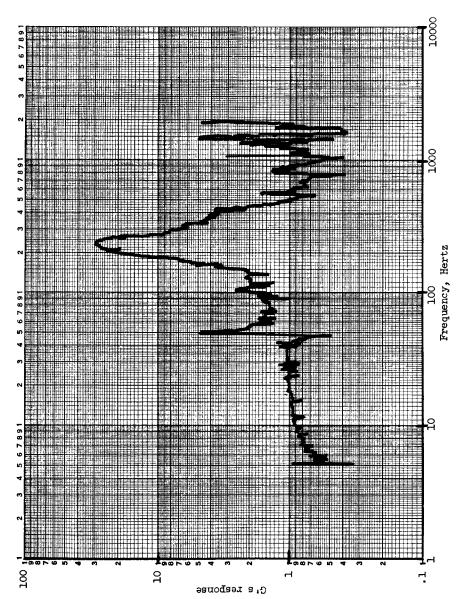
The test data showed that during the X-axis sinusoidal vibration sweep, Accelerometer #14 (X axis on the shaft assembly) recorded a 29G peak response at 230 hertz (fig. 5). Accelerometer #15 (Z axis on the shaft assembly) recorded a 15 G peak response at 230 hertz (fig. 6). The data from Accelerometers #14 and #15 taken during this test are considered as typical, but they show the maximum recorded responses during this vibration sweep. Accelerometers #16 and #17 failed to function during this test.

Figure 5. - Typical response of X axis accelerometer #14 to 1G X axis sine input for octave/min sweep.

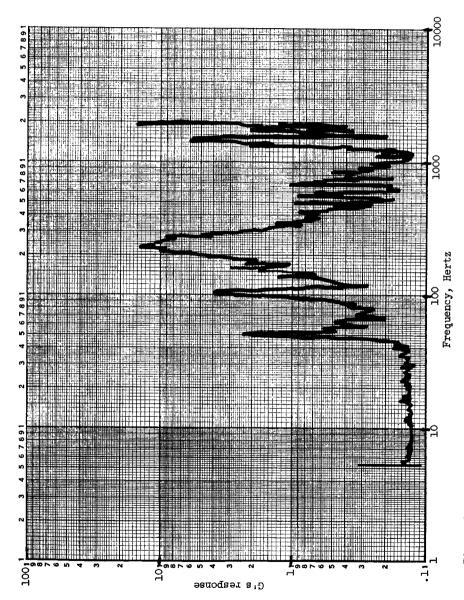
axis accelerometer #15 to 1G X axis sine input with Ŋ  $_{
m Jo}$ Figure 6. - Typical response octave/min sweep.

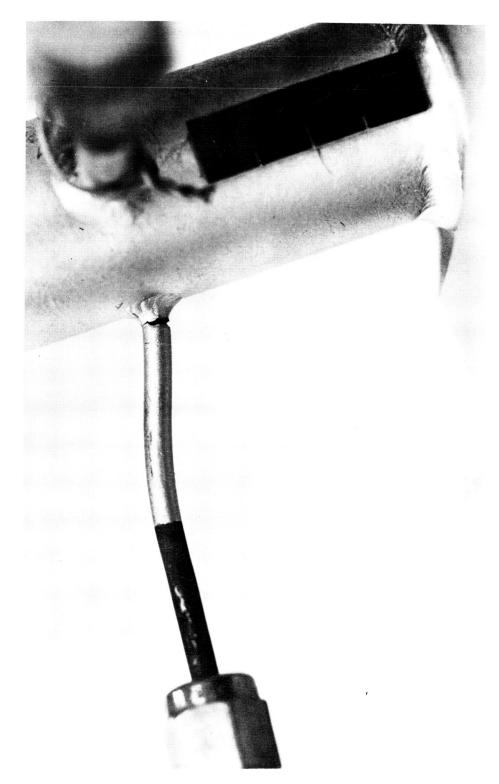
A visual examination of the pump revealed a crack at the root weld on a 3.2-millimeter (1/8 in.) pressure tap in the pump suction line (fig. 7).

The pressure tap that cracked at the weld, and similar pressure taps on other lines were cantilever mounted with relatively large-mass closure cups on the ends. The large mass caused excessive vibration amplitudes and resulted in this weld crack. The pressure taps were provided for development testing and would probably be eliminated from a flight system or, if retained, would be better supported.

Figure 7. - SNAP-8 mercury pump after vibration testing. Pump housing showing crack at weld of pump suction line, pressure tap.

- 1. The loss of bearing preload can be considered as a possible potential failure since subsequent successful operation of the unit would be questionable. This could be corrected by redesign of the bearing housing to employ hardened steel liners or hard chroming the housing surfaces to improve sliding of the bearing outer rings.
- 2. The motor loosening and loss of torque on the locknut are a minor problem since function was not affected.
- 3. Small unsupported pressure taps cannot survive the vibration testing.

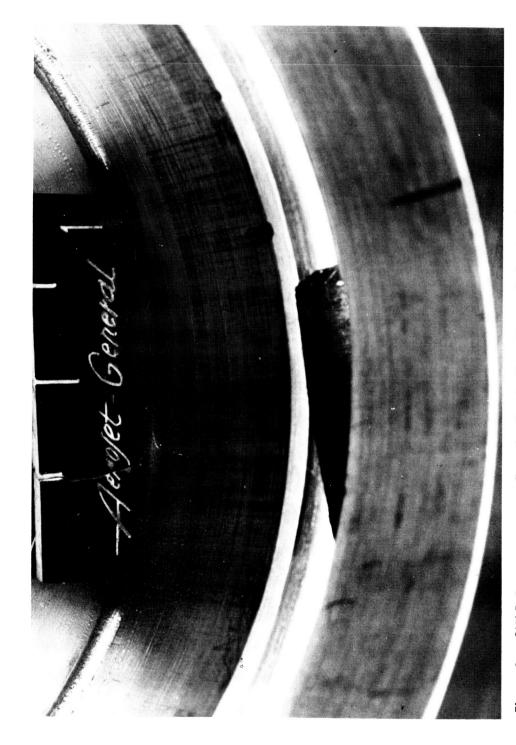
The inner rings of both bearings came off the shaft freely and without damage, but both of the outer rings were tight in the housing bores and had to be pressed out. Under normal condition these outer rings are free to slide in the housing within the preloading limits. Numerous V-shaped shallow gouge marks were made in the housing surfaces during the bearing outer-ring removal (figs. 8 and 9). Out-of-roundness for the bearing seats in the housing was measured as 0.00020-centimeter (0.00008-in.) total indicator reading (T.I.R.) at the motor end, and 0.00025-centimeter (0.00010-in.) T.I.R. at the pump end. The high points did not match the damage pattern in a regular fashion. This was checked to eliminate the possibility of grinding chatter as a major contributor to the problem. The outside diameters of both bearings and both housing bores were inspected to locate any possible ridges

The housing had galled in several places and had deposited metal in a cold-welded fashion onto the bearing outer rings, keying them to the housing. These cold-welded deposits gouged the housing as the bearings were pressed out. The bearing stops showed no impact effects. The preload springs were undamaged and were within calibration limits.

Figure 8. - SNAP-8 mercury pump after vibration testing. Transmission housing showing damage to pump end bearing seat.

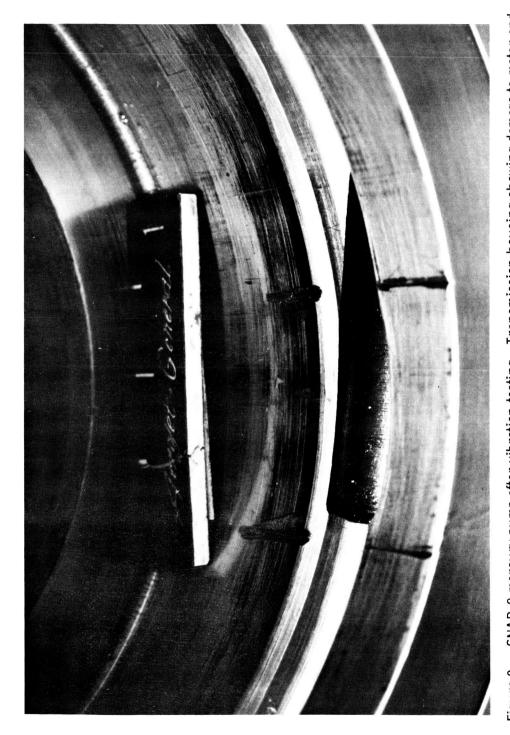
The greater amount of bearing and housing damage occurred at the motor end as expected since the overhung motor mass is largely supported by the motor-end bearing. The pump-end bearing is additionally protected by the carbon seals which provide damping of any motion at the pump end. The low  $[0 \text{ radian } (0^0)]$  contact-angle pattern found in the motor-end bearing indicated a complete loss of preload during a portion of the testing. The loss of bearing preload permitted large displacements of the shaft and explained the damage to the antirotation device. The reorientation of the balls and the bearings rings would not have occurred if the preload had been continuously applied.

Figure 9. - SNAP-8 mercury pump after vibration testing. Transmission housing showing damage to motor end bearing seat.

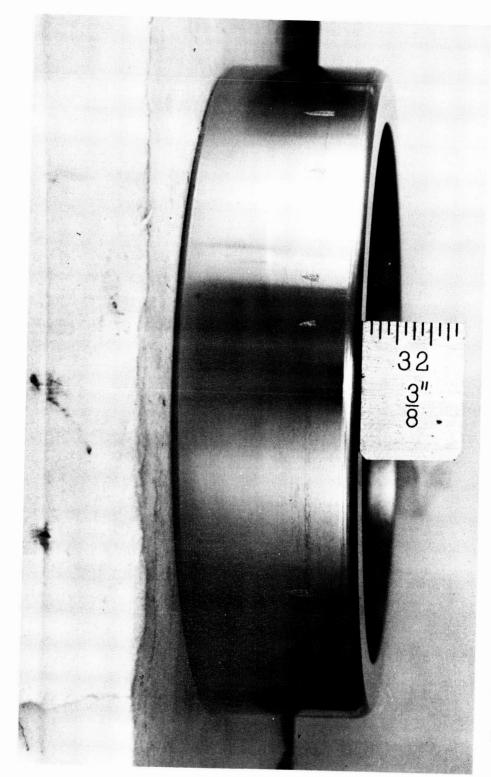
Pump-end bearing. - The outer ring of the pump-end bearing (fig. 10) had nine large galled or material-pickup areas measuring approximately one millimeter by 3 millimeters (0.04 by 0.12 in.) each, and several small areas distributed around the circumference. All damage marks started at approximately 4 millimeters (0.16 in.) from the nonthrust face as chatter marks that extended across the ring towards the thrust face. This was caused by axial displacement of the outer race. Between the galls was a narrow circumferential band of disturbed finish which delineates a plane of contact around the periphery of the bearing. The outer raceway was free of all signs of vibration damage. A few very light raceway scratches appeared to be the result of efforts to remove the outer rings from the housing.

Figure 10. - SNAP-8 mercury pump after vibration testing. Pump end bearing outer ring showing galls and scratches.

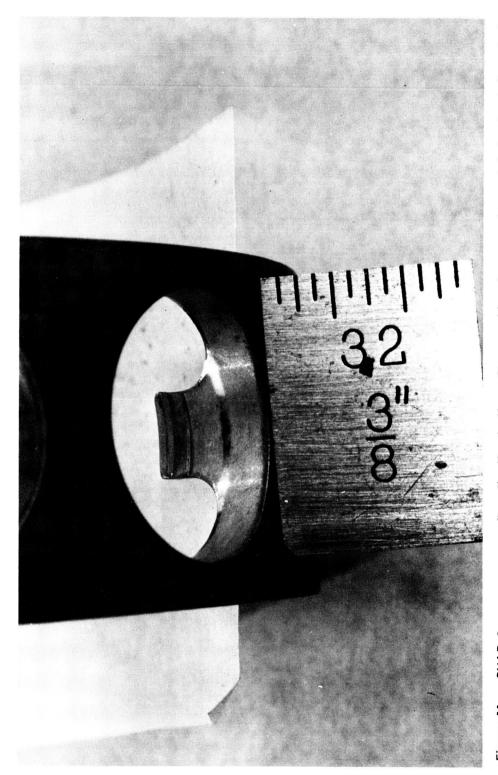
The raceway of the inner ring was undamaged. Extremely light ball tracks were attributed to noise testing of the bearing as part of the manufacturer's acceptance tests. Light axial mounting marks were seen in the bore. The balls were entirely free of any damage or marking. The separator (fig. 11) showed a light ball contact pattern in the pockets and a light contact pattern on the outside diameter.

Figure 11. - SNAP-8 mercury pump after vibration testing. Pump end bearing separator pocket showing ball contact pattern.

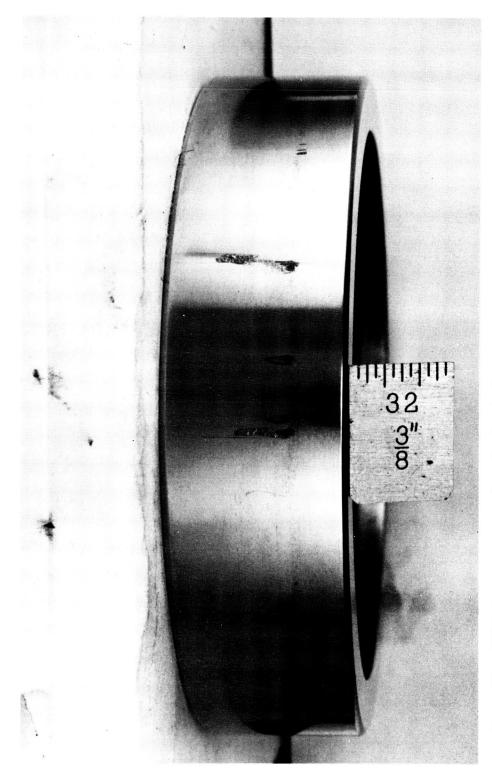
Motor-end bearing. - The outer ring of the motor-end bearing (fig. 12) had 17 galled areas of various sizes distributed around the outer diameter. The galled areas started at approximately 4.8 millimeters (0.19 in.) from the nonthrust face. In line with the galls was a light narrow circumferential band of disturbed finish which appeared to have been generated by repeated contact with the housing bore. The raceway had very light ball-contact patterns at 0.26 and 0 radian (150 and 00) contact angles with normal ball spacing. The nonthrust portion of the raceway had minor scratches, probably from the disassembly efforts.

Figure 12. - SNAP-8 mercury pump after vibration testing. Motor end bearing outer ring showing galls and scratches.

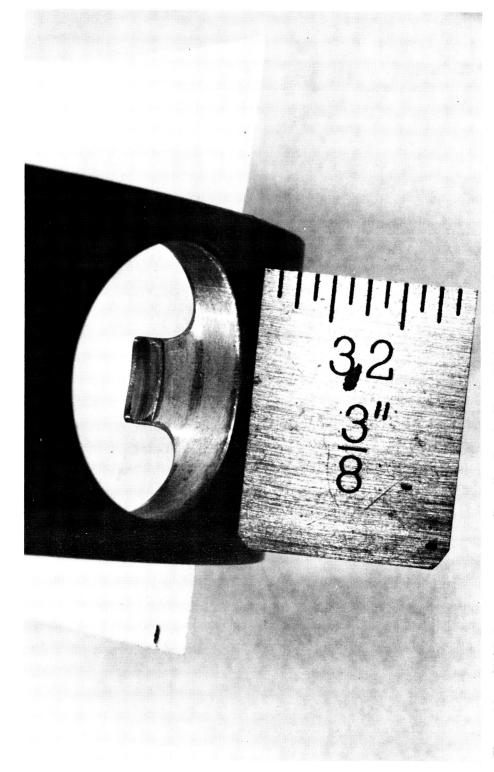
The balls were in excellent condition. The separator (fig. 13) showed a light ball-contact pattern in the pockets and a light contact pattern on the outside diameter.

Figure 13. - SNAP-8 mercury pump after vibration testing. Motor end bearing separator pocket showing ball contact pattern.
